# Workshop Manual

## 3000GT '98

# MITSUBISHI 3000GT WORKSHOP MANUAL SUPPLEMENT

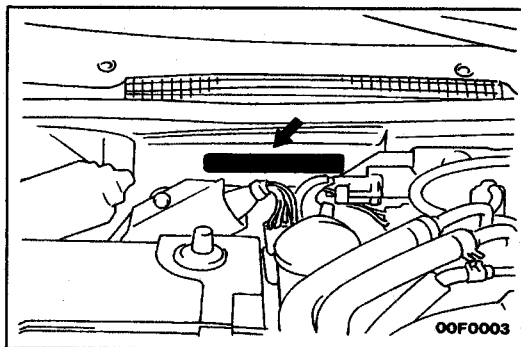
V0207AA

#### CHASSIS NUMBER

The chassis number is stamped on the toeboard inside the engine compartment.

1. Asia
2. Japan
3. MITSUBISHI
  - A - For Europe, right hand drive
  - B - For Europe, left hand drive
  - F - For Australia, right hand drive
  - Y - For General Export or GCC
4. Body style
  - M - 2-door hatchback
5. Transmission type
  - N - 5-speed manual transmission
  - J - 6-speed manual transmission
6. Development order
  - Z16 - 2,972 ml (Full time 4WD)
7. Sort
  - A - Passenger car
8. Model year
  - W - 1998
9. Plant
  - Y - Ohe Motor Vehicle Works
10. Serial number

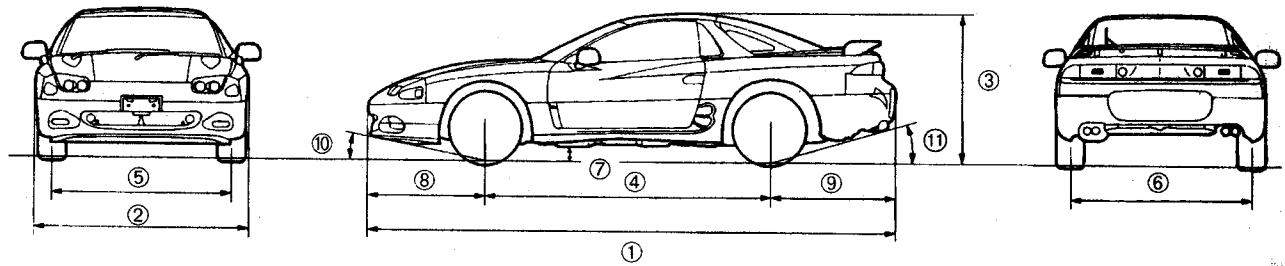
00F0664

## Dimensions

Items		Z16AMJGFL6 Z16AMJGFL6	Z16AMNGFL Z16AMNGFR Z16AMNGFLW	Z16AMNGFR8
Overall length mm (in.)	①	4,570 (1799.9)	4,570 (1799.9)	4,570 (1799.9)
Overall width mm (in.)	②	1,840 (72.4)	1,840 (72.4)	1,840 (72.4)
Overall height (unladen) mm (in.)	③	1,285 (50.6)	1,285 (50.6)	1,285 (50.6)
Wheelbase mm (in.)	④	2,470 (97.2)	2,470 (97.2)	2,470 (97.2)
Track-front mm (in.)	⑤	1,560 (62.2)	1,560 (62.2)	1,560 (62.2)
Track-rear mm (in.)	⑥	1,580 (62.2)	1,580 (62.2)	1,580 (62.2)
Ground clearance (unladen) mm (in.)	⑦	140 (5.5)	140 (5.5)	140 (5.5)
Overhang-front mm (in.)	⑧	1,030 (40.6)	1,030 (40.6)	1,030 (40.6)
Overhang-rear mm (in.)	⑨	1,070 (42.1)	1,070 (42.1)	1,070 (42.1)
Angle of approach	⑩	11.2°	11.2°	11.2°
Angle of departure depress	⑪	11.7°	11.7°	11.7°

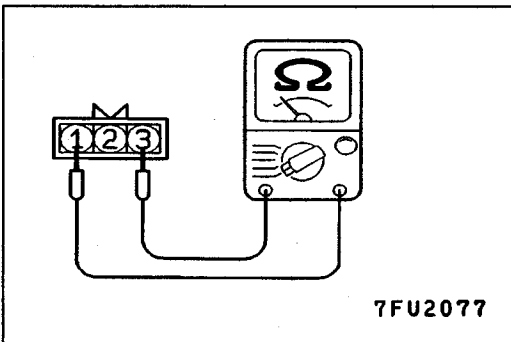
**SENSOR INSPECTION**

- (1) Disconnect the variable resistor connector.
- (2) Use a circuit tester to measure the resistance between terminal ① and terminal ③ of the variable resistor connector.

**Standard value: 4 – 6 kΩ**

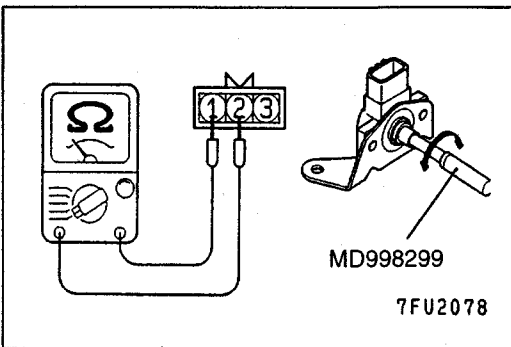
- (3) Next, connect the circuit tester between terminal ① and terminal ②.
- (4) Check if the resistance changes smoothly when the adjusting screw is rotated by the special tool (MAS driver).
- (5) Inspect the body for cracks or other damage.
- (6) If any defect is found, replace the variable resistor as an assembly.

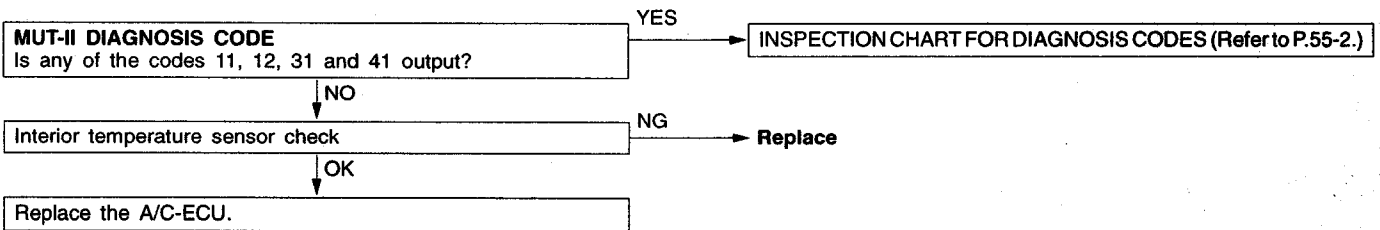
**Inspection procedure 5**

<b>A/C outlet air temperature does not increase.</b>	<b>Probable cause</b>
If the outlet air temperature does not increase when the temperature setting is increased, the cause is probably a sensor malfunction or a problem with operation of the blend air damper. The MUT-II can be used to check the diagnosis codes in order to check the cause of the problem for each separate system.	<ul style="list-style-type: none"> <li>● Malfunction of blend air damper potentiometer</li> <li>● Malfunction of blend air damper motor</li> <li>● Malfunction of blend air damper</li> <li>● Malfunction of connector or harness</li> <li>● Malfunction of interior temperature sensor</li> <li>● Malfunction of A/C-ECU</li> </ul>

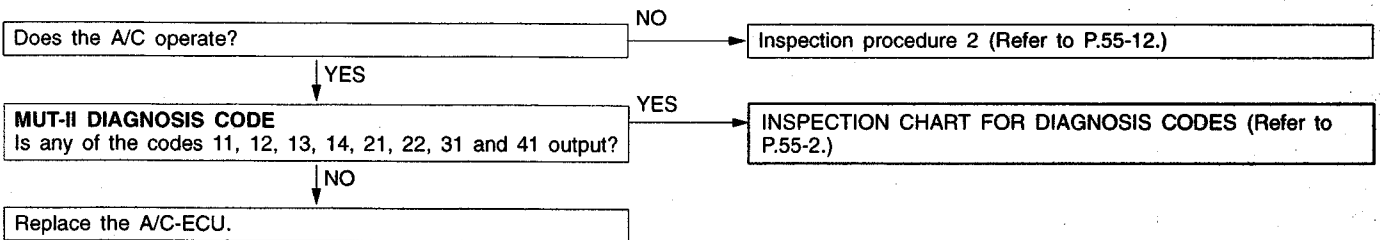
**Inspection procedure 6**

<b>A/C outlet air temperature does not decrease.</b>	<b>Probable cause</b>
If the outlet air temperature does not decrease when the temperature setting is decreased, the cause is probably a problem in A/C system operation due to a sensor error, or a problem with operation of the blend air damper. The MUT-II can be used to check the diagnosis codes in order to check the cause of the problem for each separate system.	<ul style="list-style-type: none"> <li>● Malfunction of blend air damper potentiometer</li> <li>● Malfunction of blend air damper motor</li> <li>● Malfunction of air thermo sensor</li> <li>● Malfunction of connector or harness</li> <li>● Malfunction of blend air damper</li> <li>● Malfunction of A/C-ECU</li> </ul>

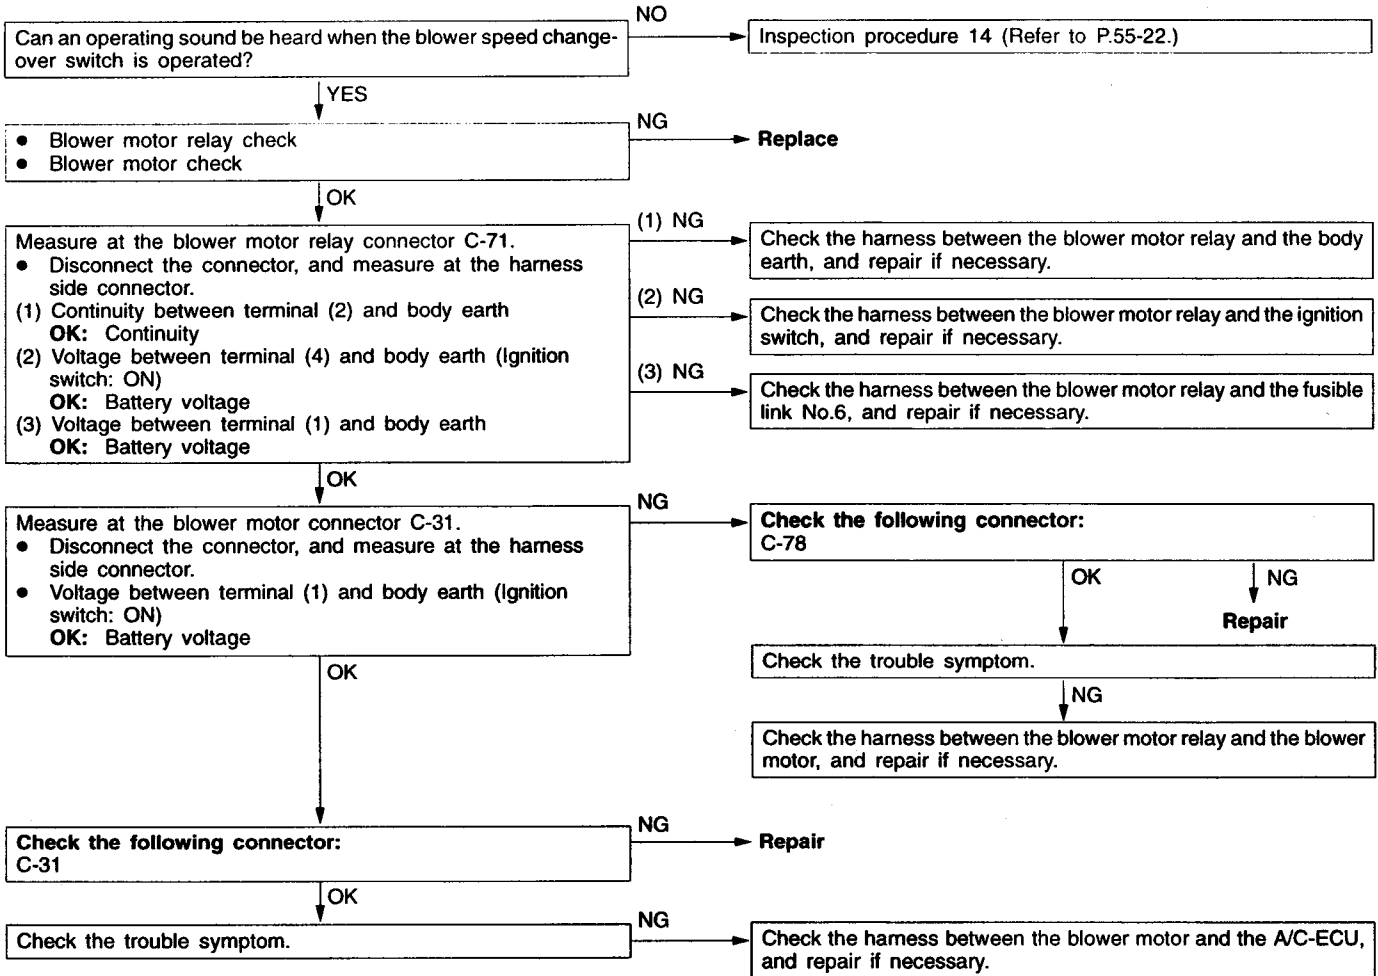
## Inspection procedure 7

Blower does not operate.	Probable cause
If no air comes out of the blower even though the blower switch is on, the cause is probably a malfunction of the blower motor relay circuit.	<ul style="list-style-type: none"> <li>● Malfunction of blower motor relay</li> <li>● Malfunction of blower motor</li> <li>● Malfunction of connector or harness</li> <li>● Malfunction of A/C-ECU</li> </ul>
